Manhole Inspection Summary

Manhole # S350O1017MH

Location Address: **313 KERNE WAY**

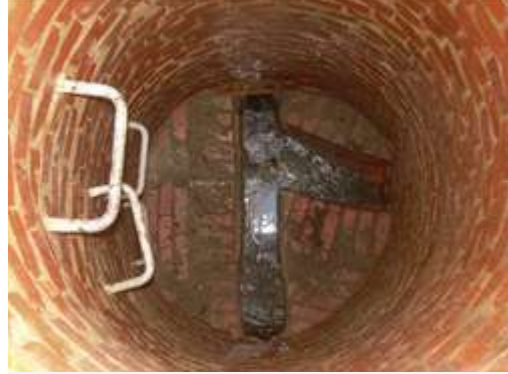
Top View

Evidence of surcharge - Bench debris.
Channel debris.

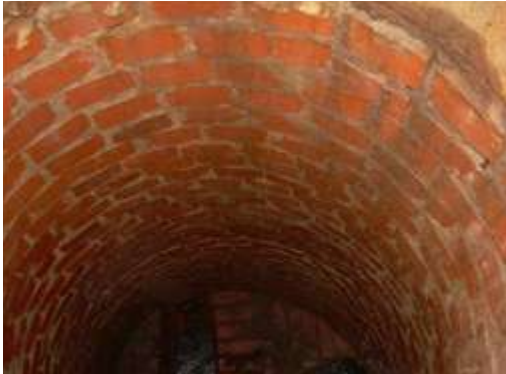
Defect

Frame leaks. Adjustment deterioration
and infiltration. Barrel infiltration.

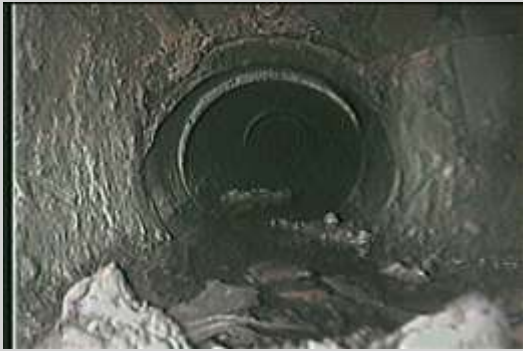
8 in. Circular Gravity Sewer Pipe Out @ 12 O'Clock

Deposits: ☐ None ☒ **Mud** ☐ Sludge ☒ **Debris** ☐ Grease

Silt Depth: **0.5** (in.) Deposits Extent: **Light**

Infiltration: **Evidence** Pipe Seal Cond: **Broken**

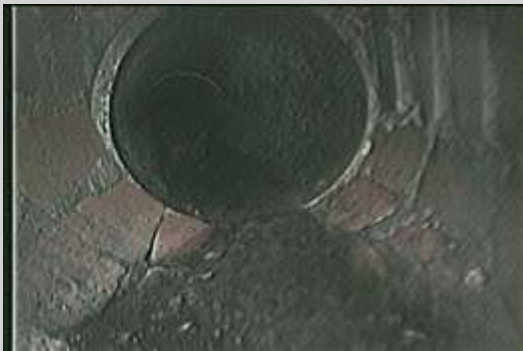
8 in. Circular Gravity Sewer Pipe In @ 3 O'Clock

Deposits: ☐ None ☒ **Mud** ☐ Sludge ☒ **Debris** ☐ Grease

Silt Depth: **0.5** (in.) Deposits Extent: **Light**

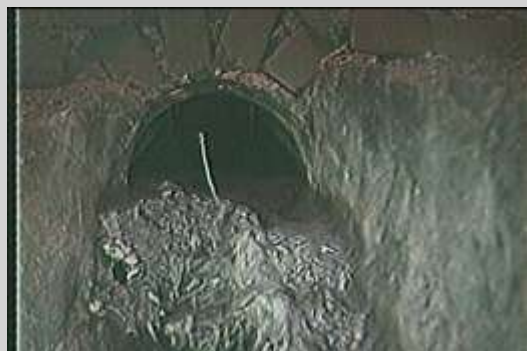
Pipe In @ 6 O'Clock

Barrel deterioration and infiltration. Channel debris.

Deposits: ☐ None ☐ Mud ☐ Sludge ☒ **Debris** ☐ Grease

Silt Depth: **3** (in.)

Infiltration: **Evidence**

Pipe Seal Cond: **Cracked**
